Water Quality Monitoring of *Estero de Paco, Manila*

Maria Antonia N. Tanchuling
University of the Philippines

3E Nexus Project Kick-off Meeting
24 – 25 February 2014
Maldives

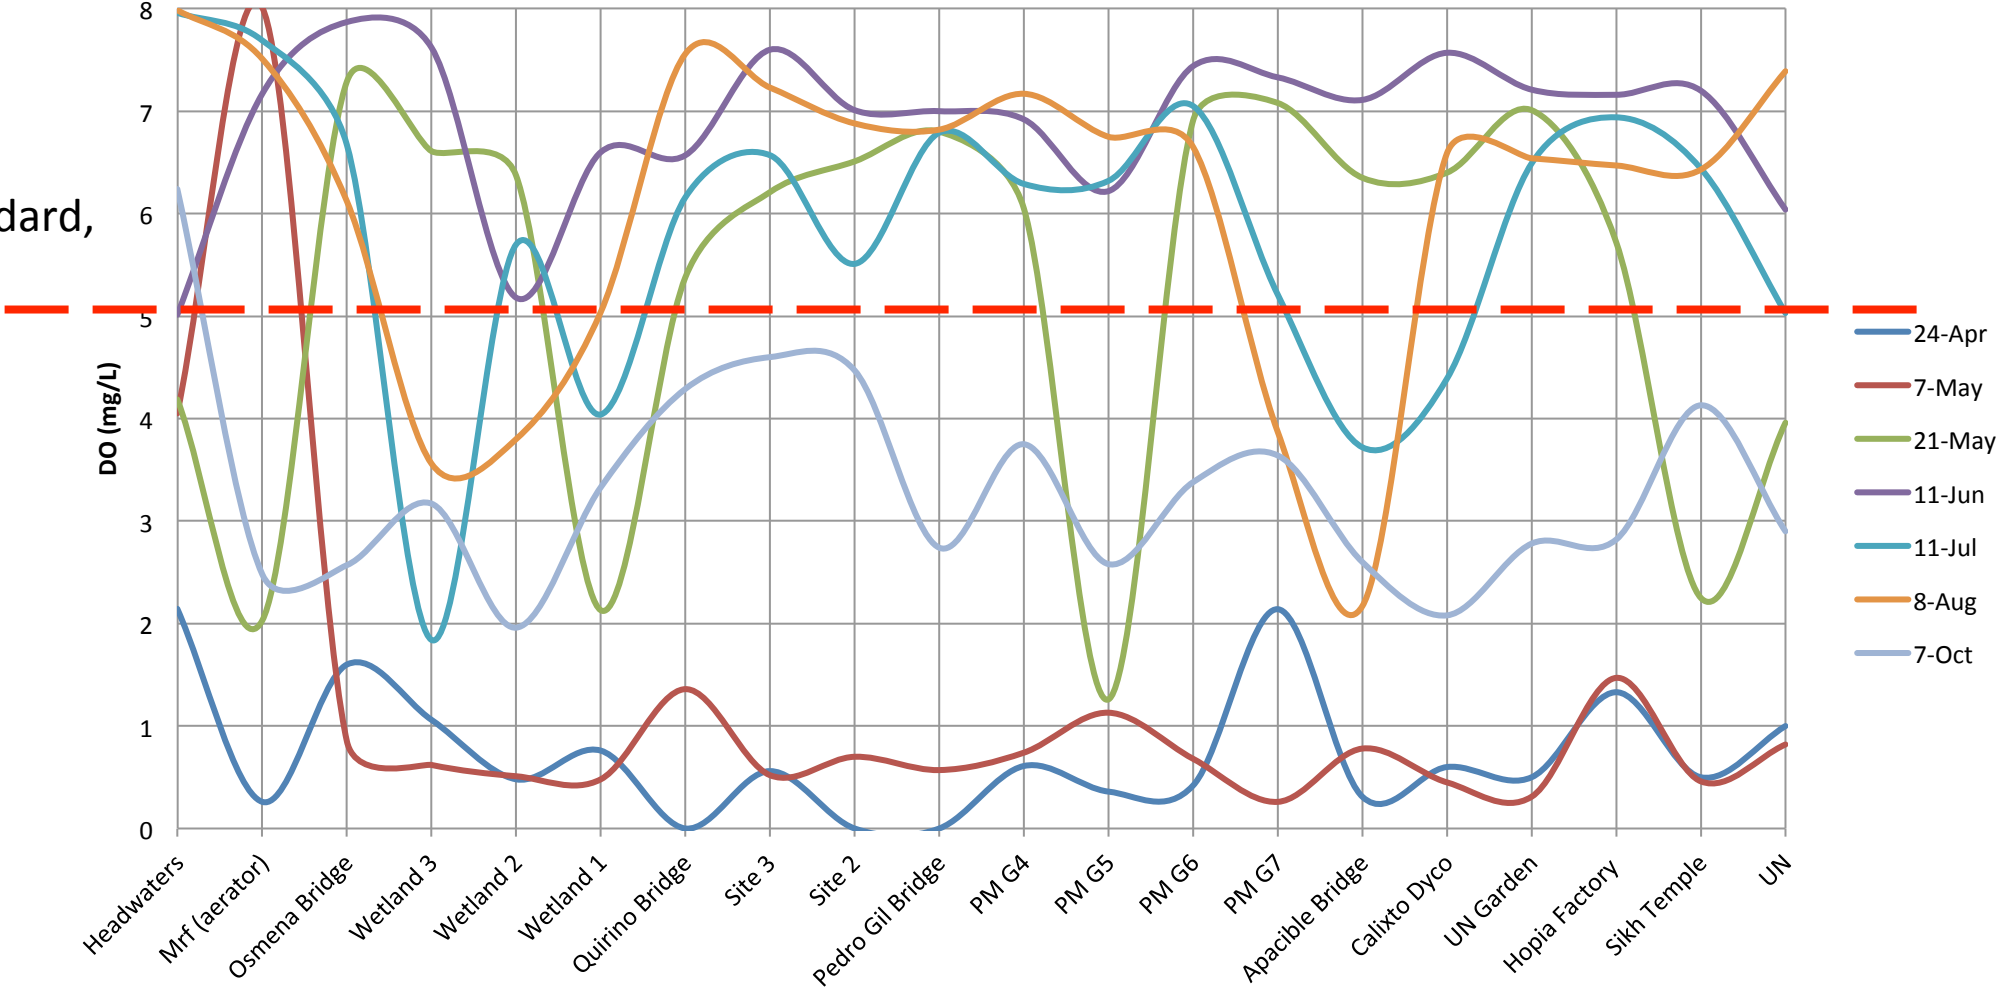
DO per station (2013)

Class C Standard,
DENR

- Current treatment systems and other interventions were able to improve water quality but are inadequate to meet target quality of Class C waters
- For sustainability, no untreated discharge from residential and industrial sources should be allowed
- Aerators should be turned on
- More detailed analysis should be done prior to installation of any technology
- Oil and grease contamination needs to be addressed

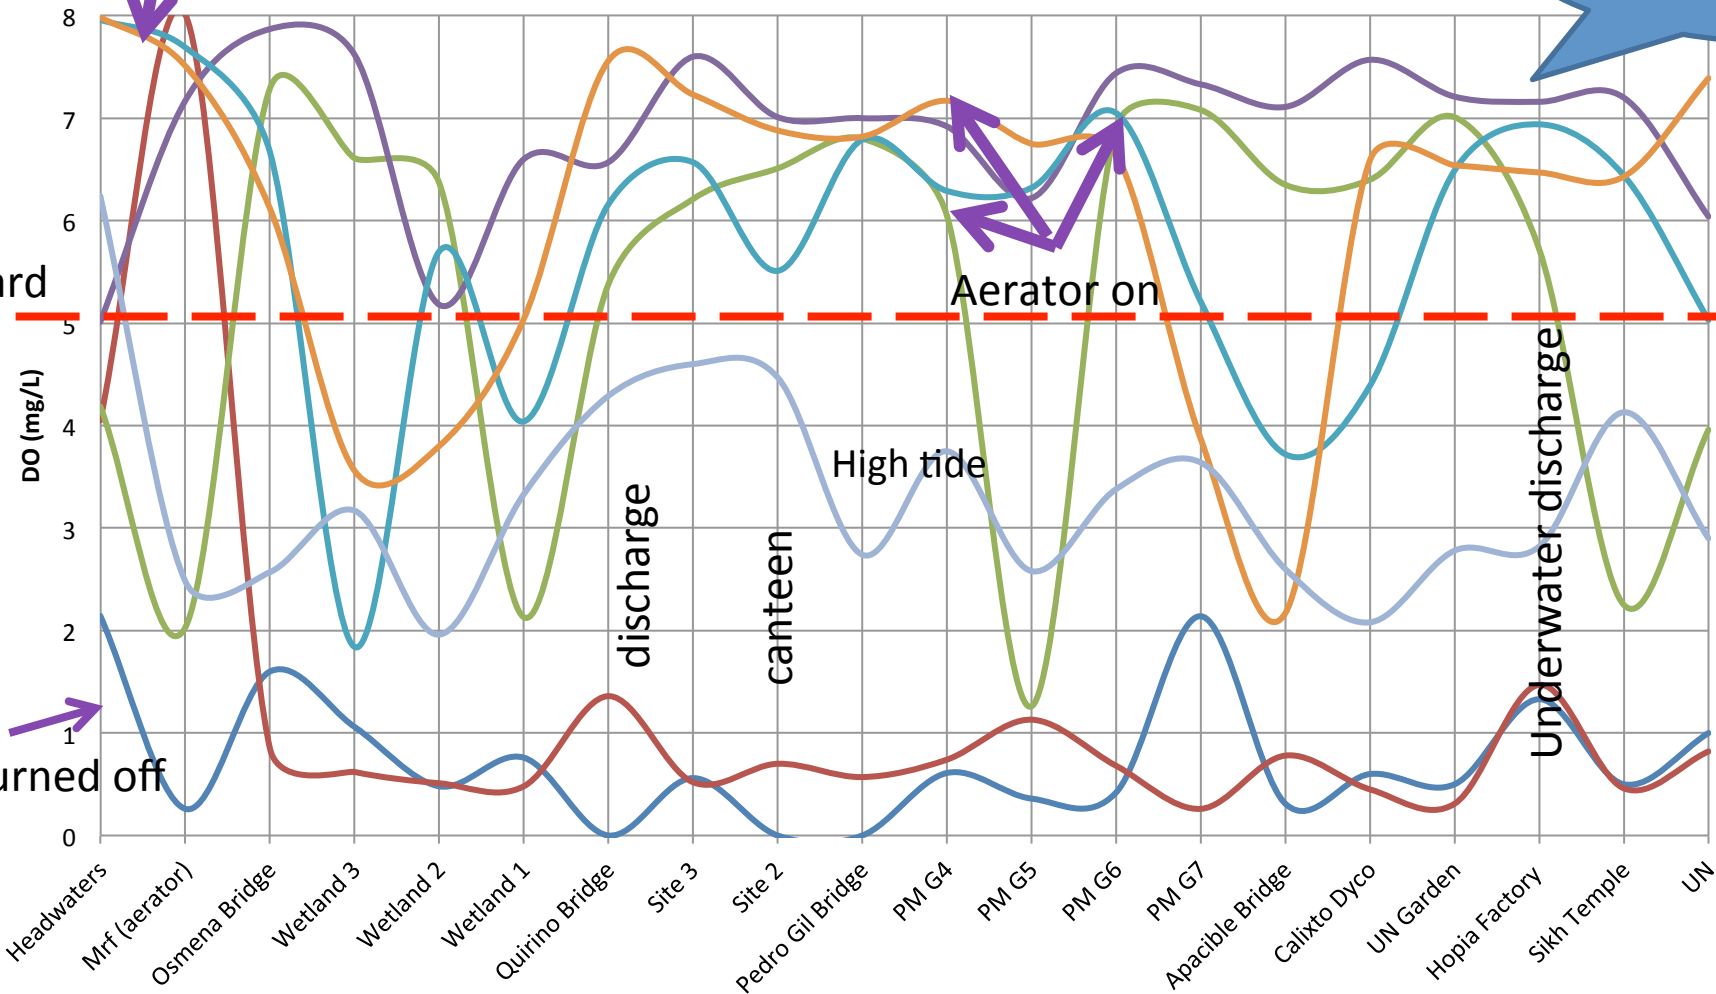
DO per station (2013)

MRF aerator on

All aerators are turned on

Class C Standard

All turned off

Aerator on

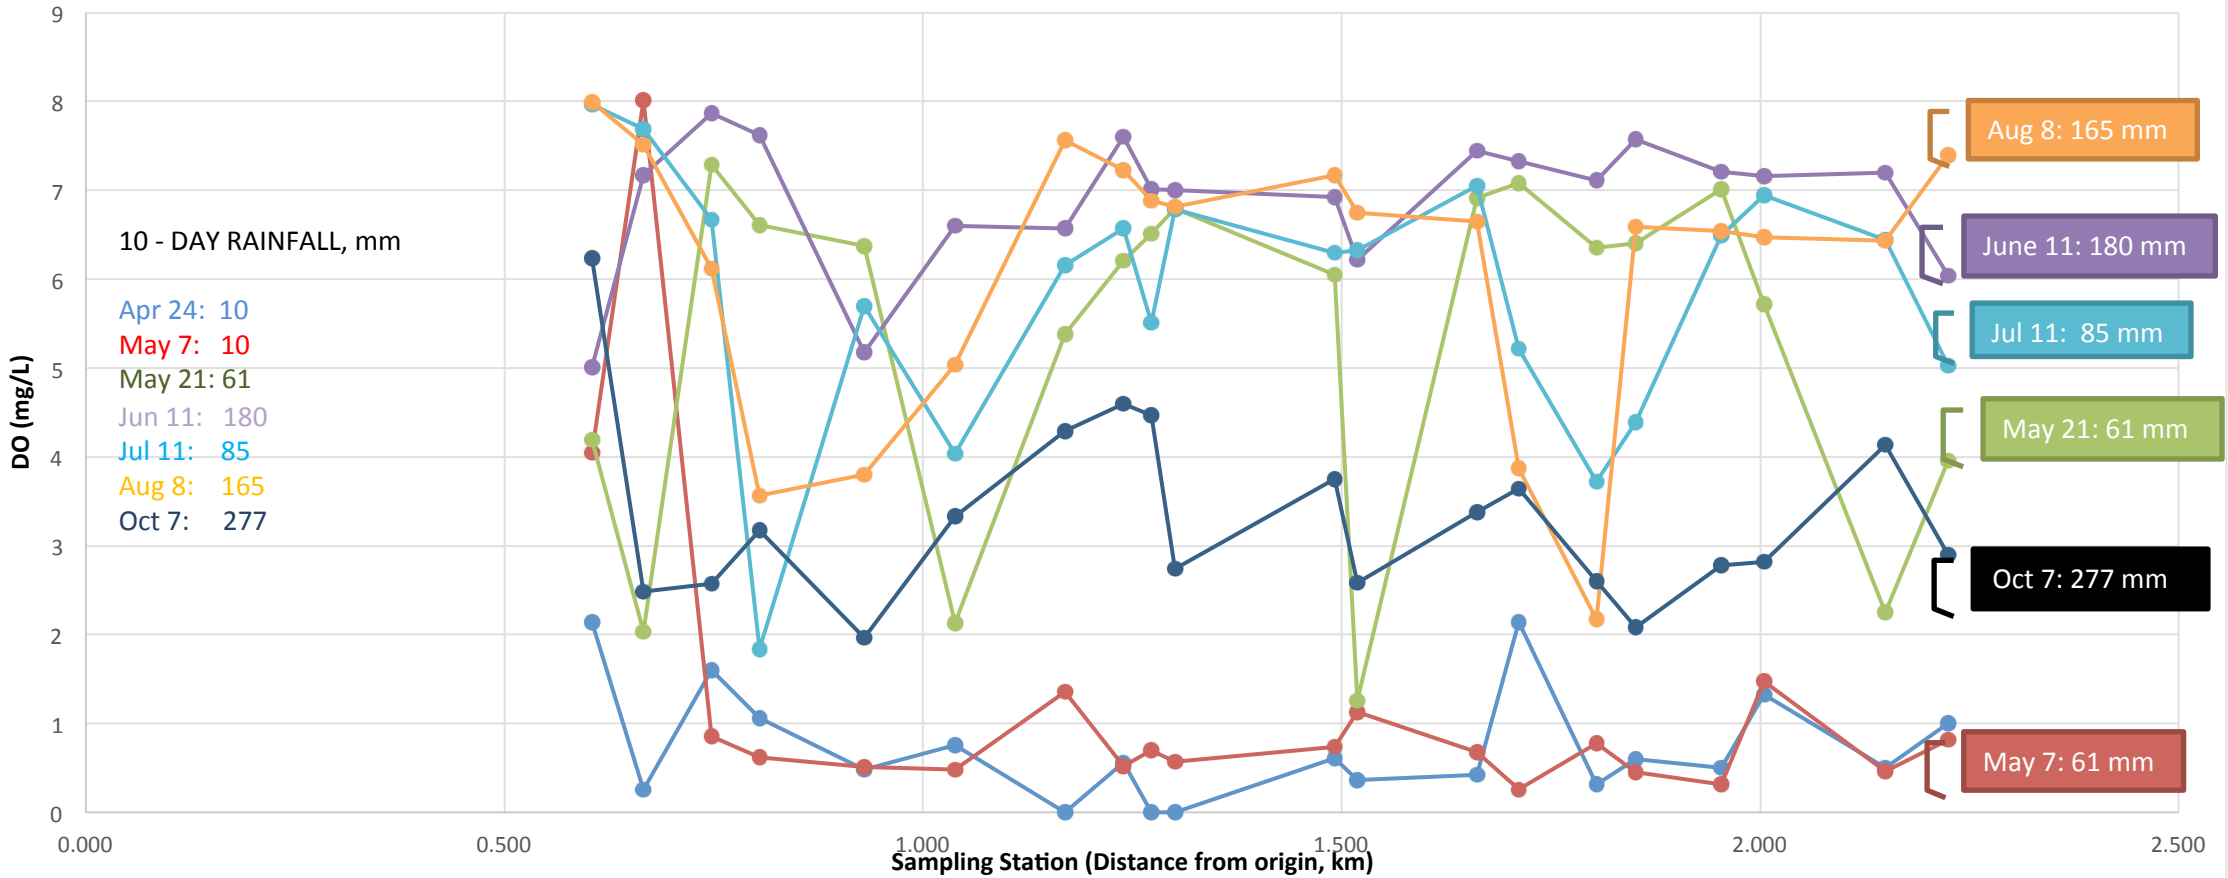
Rainfall and Dissolved Oxygen

24-Apr 7-May 21-May 11-Jun 11-Jul 8-Aug 7-Oct
